# Analysis and Improvement of the Acoustic Conditions During Ambulance Transports

– Master Thesis –

Section of Acoustics  
Department of Electronic Systems  
Aalborg University 2009  
4<sup>th</sup> Master Semester  
Project Group 09gr1064

This report describes and documents the measurements, analysis and improvement of the acoustic conditions during emergency response in the danish ambulance, model 2008.

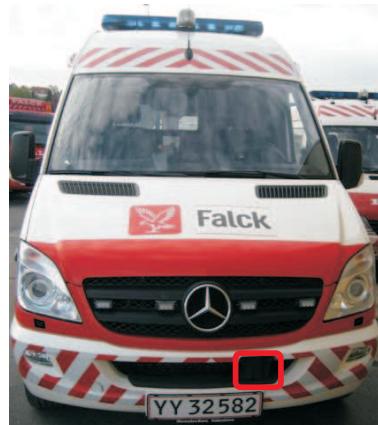
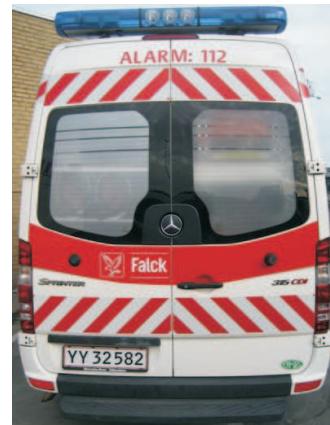
The dimensions of the ambulance were measured during a visit at Falck Aalborg. Only the dimensions relevant to this project were obtained. Figure 2.1a shows the front of the ambulance, figure 2.1b shows the rear and figure 2.2 shows the ambulance from the right side.

(a) Front of the ambulance

(b) Rear of the Ambulance.

On the former models the siren was placed on top of the ambulance however it resulted in SPLs inside the ambulance so high that it caused hearing damage to the paramedics, and was a very displeasing factor for the patients. It was therefore moved to the front of the ambulance on the newer model, as marked by the red box on figure 2.1a.

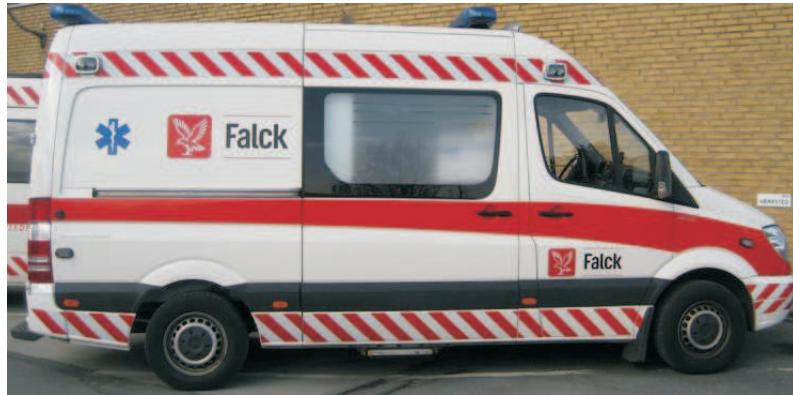
**Figure 2.2:** Right side view of the ambulance.

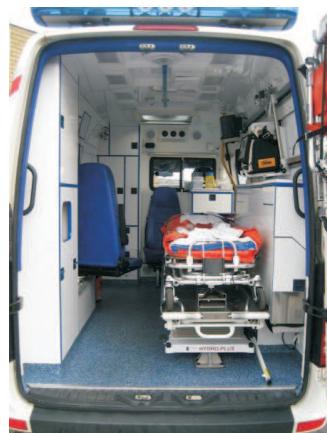
The interior of the cabin is shown on figure 2.3 with the stretcher positioned on the vibration reduction system to the right. The defibrillator and other equipment is placed in holders on the right side wall, while cabinets occupy the left side wall. Two chairs are available for paramedics, one against the partition to the driver's cabin, another next to the patient. Additional cabinets and shelves used for equipment are positioned against the partition to the driver's cabin.

**Figure 2.3:** Interior view of the ambulance.

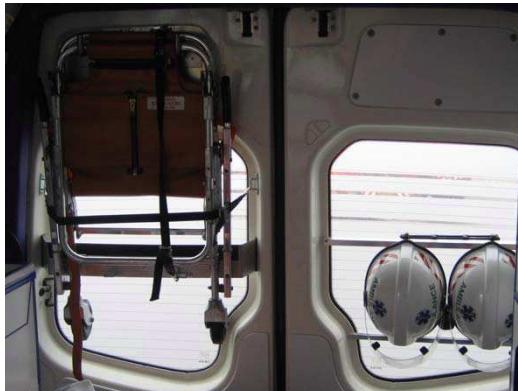
On the right rear door a stretcher chair is hanging on two brackets and fastened with two straps, see figure 4.4. The chair is collapsible, and has a frame made of aluminum. When the stretcher chair is hanging on the door, folded up, it rattles when vibrations occur. The rattling from the chair itself could be reduced by coating the aluminum frame with a kind of vibration damping materials, so it is not metal hitting metal when vibrations occur. The mounting of the chair on the door is sufficient if the aluminum frame is coated with vibration damping materials, but the strap should always be fastened as tight as possible, limiting the ability to vibrate.

**Figure 4.4:** Picture of the helmets and the stretcher chair mounted inside the ambulance.

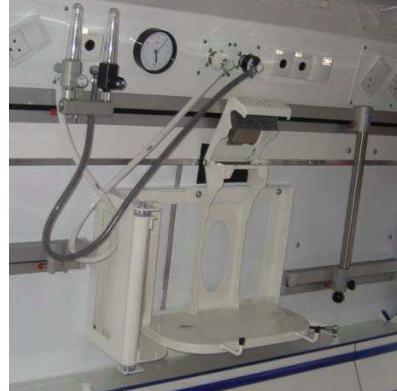
**Figure 4.5:** Picture of the defibrillator mounting.
