INDOOR ENVIRONMENT IN MULTI-STOREY RESIDENTIAL BUILDINGS

Thermal and Visual Comfort Using IV20

MASTER THESIS

4th Semester MSc. Building Energy Design

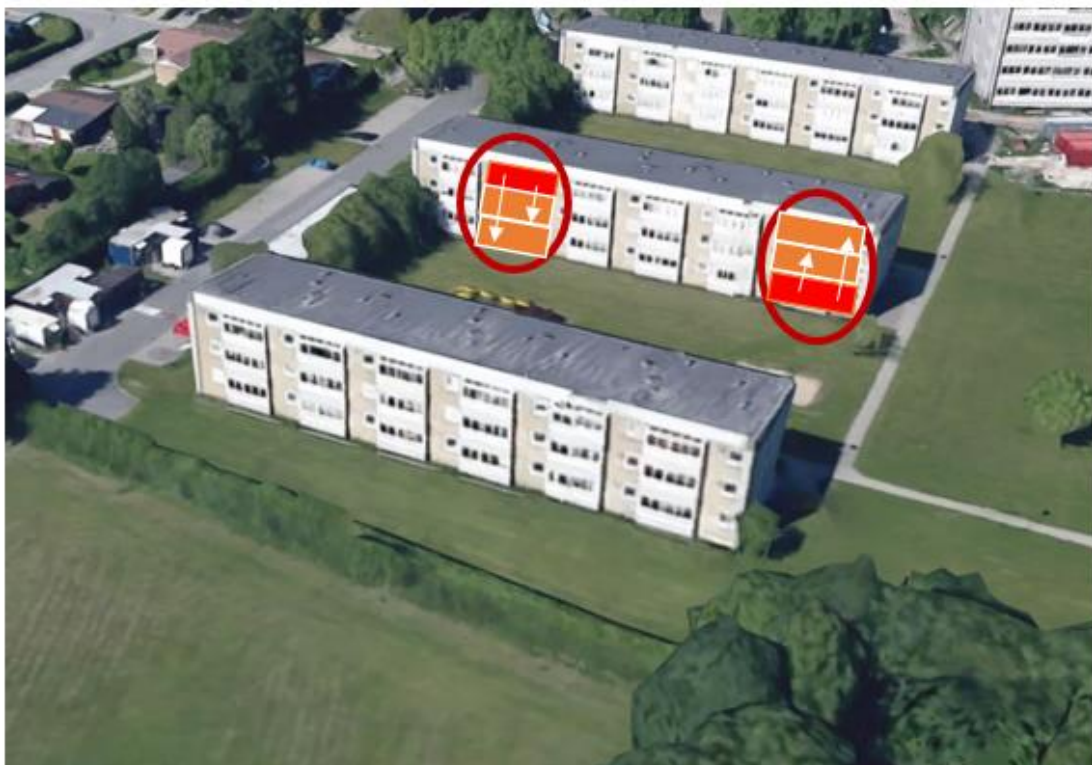
Registrations were conducted in 2 apartments at Magisterparken (427, 2nd floor to the left and 431, ground floor to the left) as showed in Figure 2.8. Other four apartments were artificially tested based on the measurements and investigations done in the first 2. In order to test the apartments assumptions were made with the information obtained during registrations and drawings from Himmerland Boligforening. The constitution of the building components was based on the authors own investigation. The u-values used for terrain deck and roof were taken from Energi Handbog based on the time period the building belongs to (roof-0,25 / floor- 1,3).

Figure 2.8 - Magisterparken, Tested Block, view from South

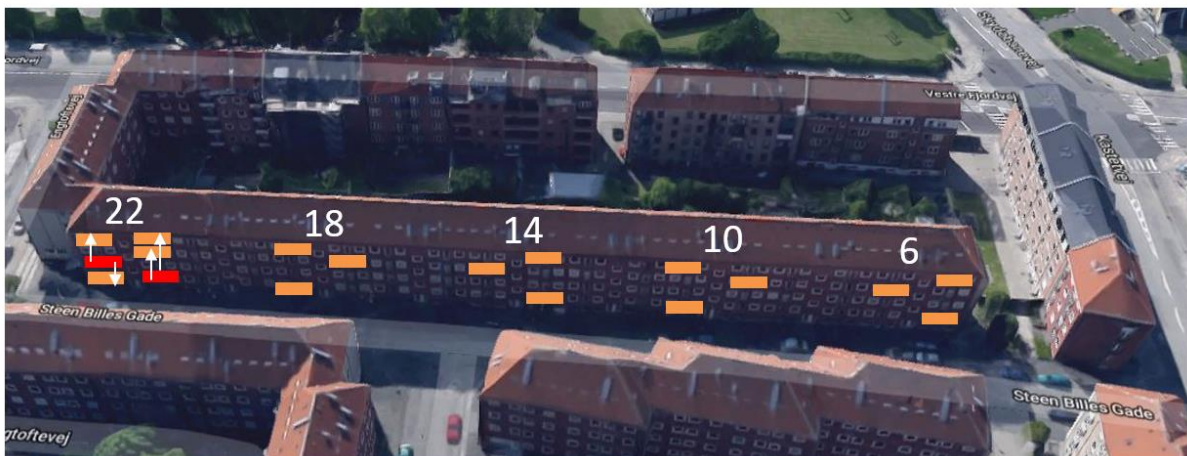
Registrations were conducted in 2 apartments at Steen Billens Gade as shown in Figure 2.17 represented as red boxed.

Figure 2.17 - Steen Billes Gade, Tested Block

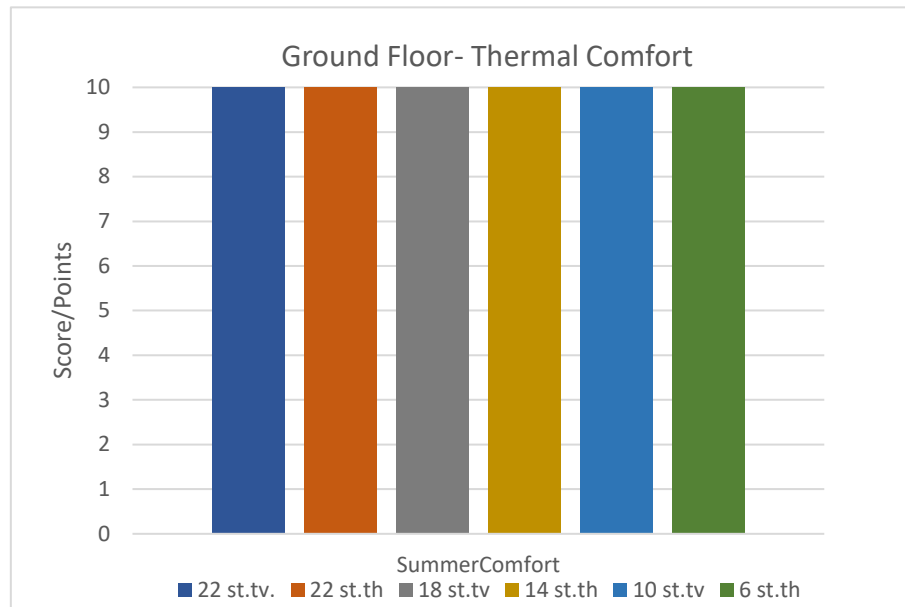
Figure 2.20 - Ground Floor and Second Floor, Thermal Comfort Results

maximum score for Summer Comfort. In real life the result might be different because the software does not account the transmission losses through the ceiling and terrain deck for the floors in between the ground and roof. All the results for summer comfort for ground, 1st and 2nd floor are similar. The only difference can be noticed between ground and 3rd floor, therefore they were included bellow.

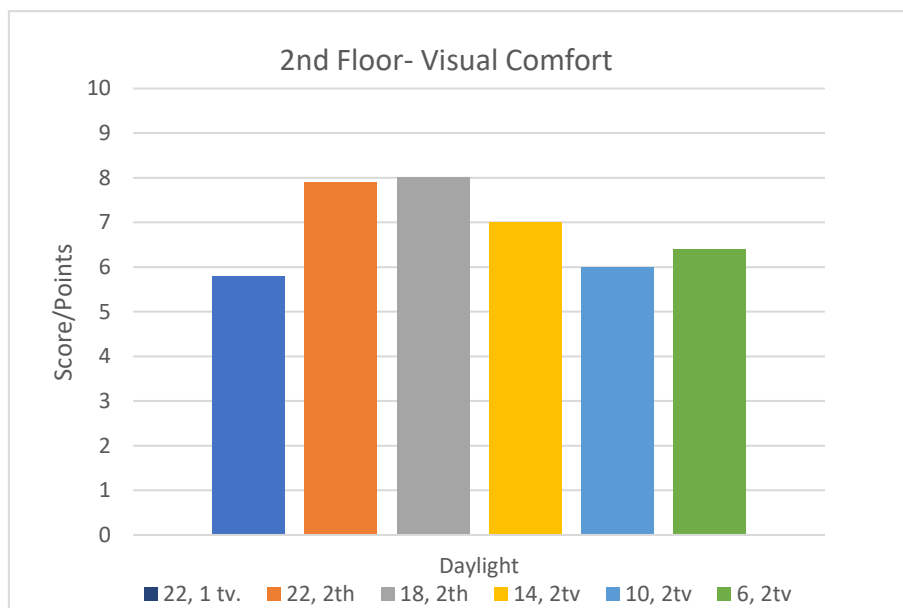
Figure 2.25 - Steen Billes Gade, 2nd Floor, Visual Comfort Results

When moving from the ground floor apartments to the top floor apartments, it can be seen in the graphs below that the score for daylight is rising, so when the height is increasing, the quantity of daylight that enters the apartment is increasing. Once reaching the top floor, the score is between 9-10 points.

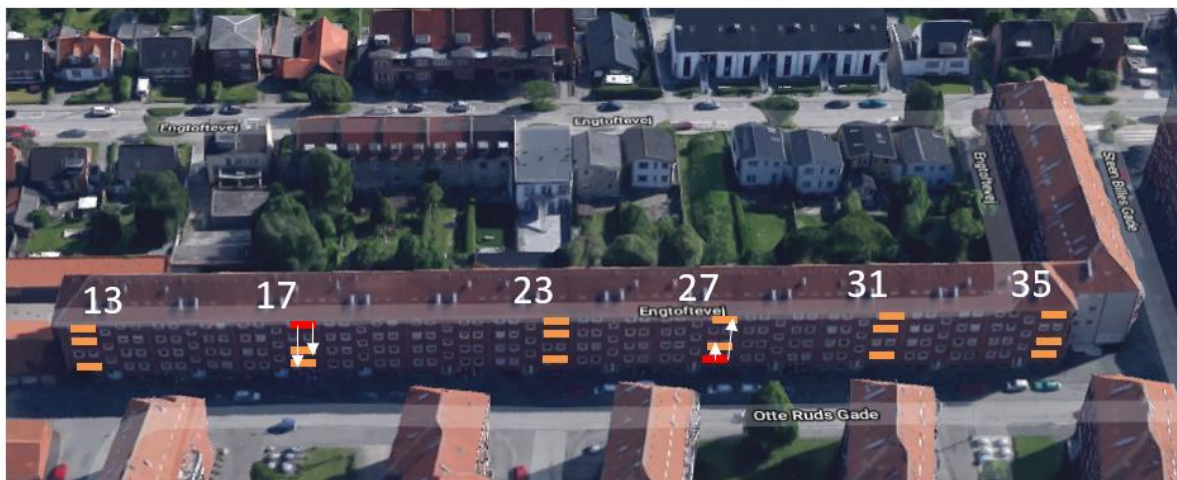
Registrations were conducted in 2 apartments (red Boxes) at Otte Ruds Gade as shown in Figure 2.27, 27, st.tv and 17, 3th. The other 16 apartments (orange boxes) were artificially tested based on the measurements and investigations done in the first 2. In order to test the apartments assumptions were made.

Figure 2.27 - Otte Ruds Gade, Tested Block

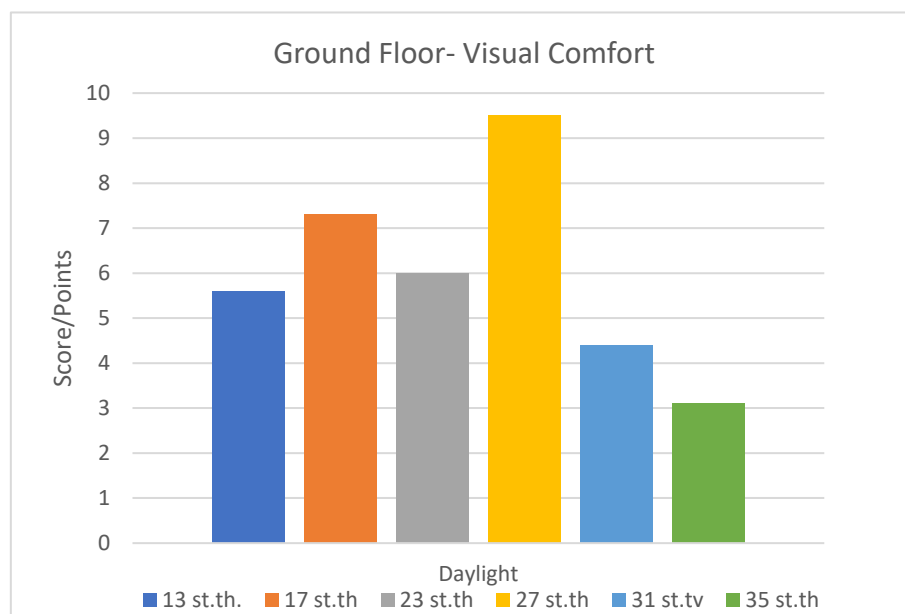
Figure 2.32 - Ground Floor, Visual Comfort Results

As in the previous cases, one of the lowest score for daylight is in the ground floor. The score is varying between 3 and 9 points. The worst condition is in apartment number 35 and 31, due to the fact that these apartments are the closest to the corner. The grading is improving when moving towards the West, where the neighboring buildings are placed in front and behind.

When analyzing the results for number 13, 17 and 23, it could be observed how they are influenced by the buildings in front.

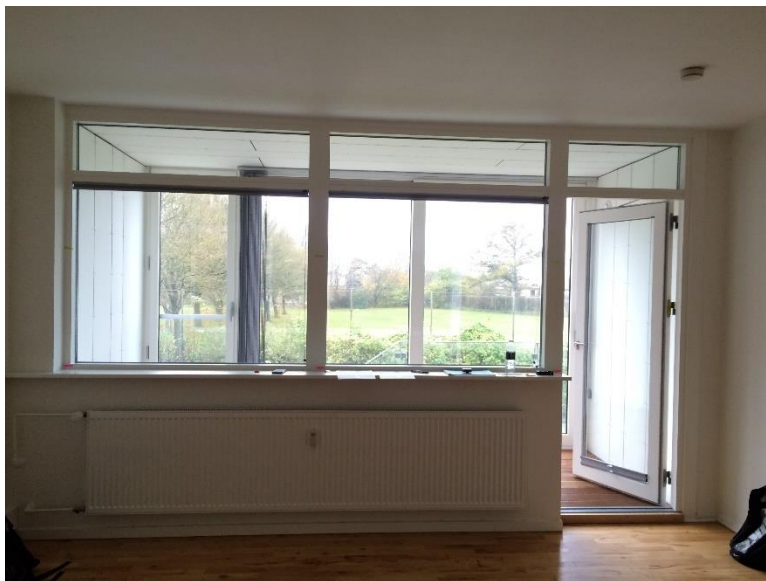
The registered apartments do not score more than C, and D due to overheating problems and poor quality of windows.

Figure 3.3 - Living Room Windows

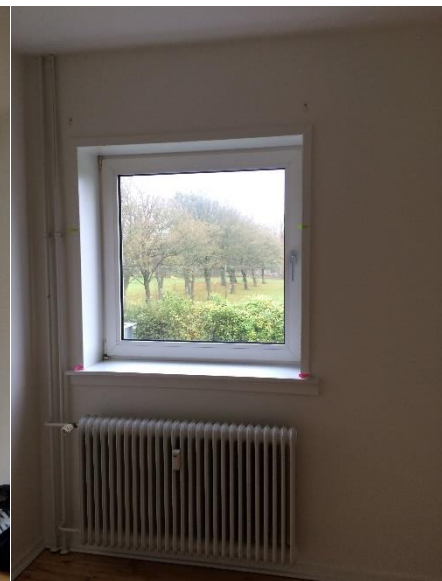
Figure 3.4 - Bedroom 1 Windows
