A NEW VENTILATED WINDOW DESIGN

Study of the impact on the indoor environment in a Danish
school from a changed ventilated window design

Aalborg University – Department of Civil Engineering
Building Energy Design Master Thesis – Group 1.307-1

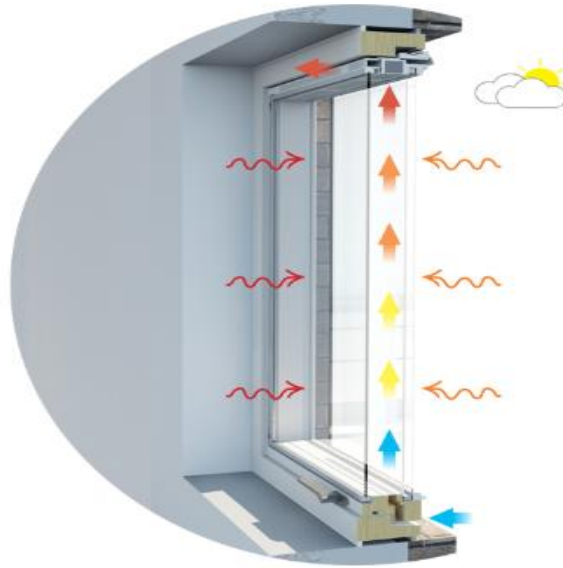
Figure 2 - Ventilated window operation - Spring and Autumn (Living Better giver verdens bedste indeklima i nybyggeri og renovering, 2019)

In spring and autumn, the air passes in through the bottom vent in the window and rise up through the cavity in the window. But here there is not only the heat losses that heats up the air but also the solar radiation from outside helps by heating the air further. Then the preheated air is supplied to the indoors. Here it is also the preheating mode.

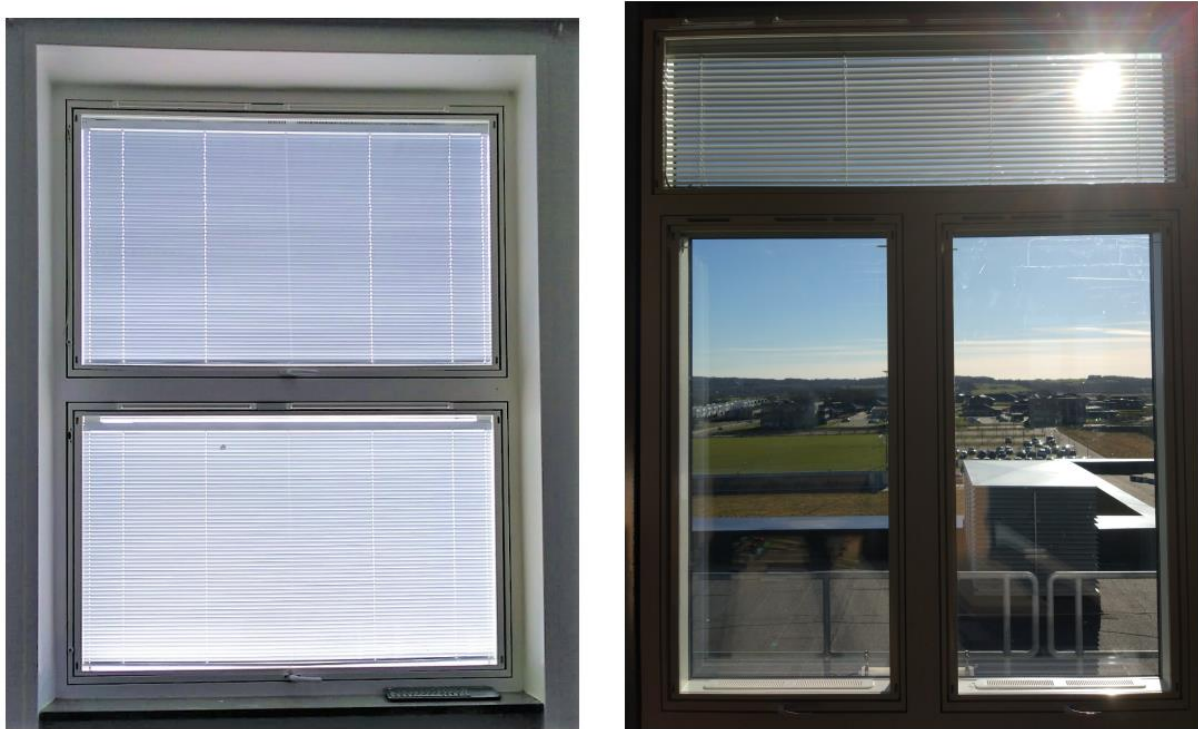
Figure 4 - Previous ventilated window design (WT1) to the left and current ventilated window design (WT2) to the right (Bonet Arbos et al., 2019)

After the previous master thesis investigation, the window design was changed in order to increase the airflow through the window. The window type 1 (WT1) had two equally sized glazing area positions, one at the top and one at the bottom. Window type 2 (WT2) had three cavities where the top one was short and wide and the two identical at the bottom were thin and tall. The different design results in different glazing area and cavity sizes.

The windows can be seen in Figure 4 with WT1 on the left and the WT2 on the right. All cavities work with the general theory described by chapter 2.1.

The main difference between the two ventilated window types in Figure 4 is the way that the valves are controlled. The window type in the WT1 (left) has thermal expansion valves that are controlled by the temperature causing them to open or close. The WT2 (right) has electrically controlled valves that are operated by a control unit placed in the room. The data investigated during the rest of the report will be distinguishable by the type of window it refers to, meaning window type 1 (WT1) refers to the previous investigation and window type 2 (WT2) refers to the current investigation.

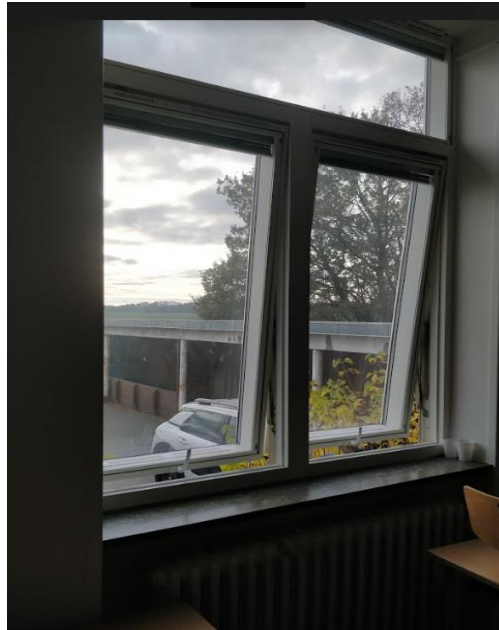
Figure 5 - Manually opening WT2 with handle

The windows WT2 can also be opened manually to supply fresh air by venting as seen on Figure 5.

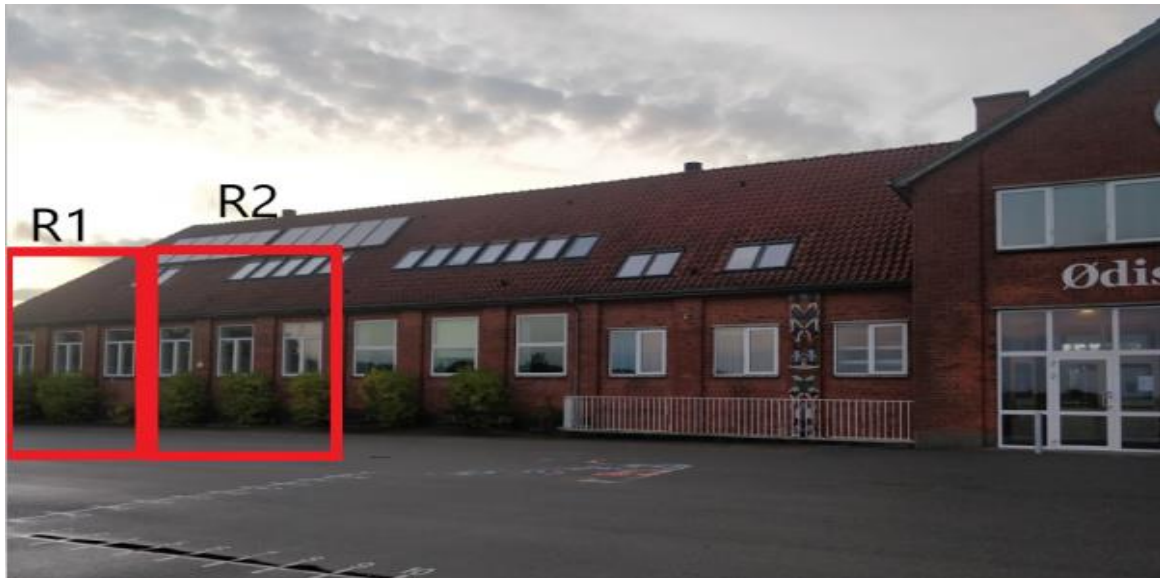
Figure 8 - Room 1 and 2 seen from outside at Ødis School

The rooms that are the focus of the investigation in this report are two neighboring rooms placed in the south facing side, as shown in Figure 8 where room 1 (R1) has natural ventilation and room 2 (R2) has mechanical ventilation. R1 is the end room and has two external walls whereas R2 only has one external wall. Both rooms have only brick walls and a wooden ceiling.

In Figure 8 the two rooms can be seen from the outside with the new window design WT2 installed and their placement according to the main entrance.

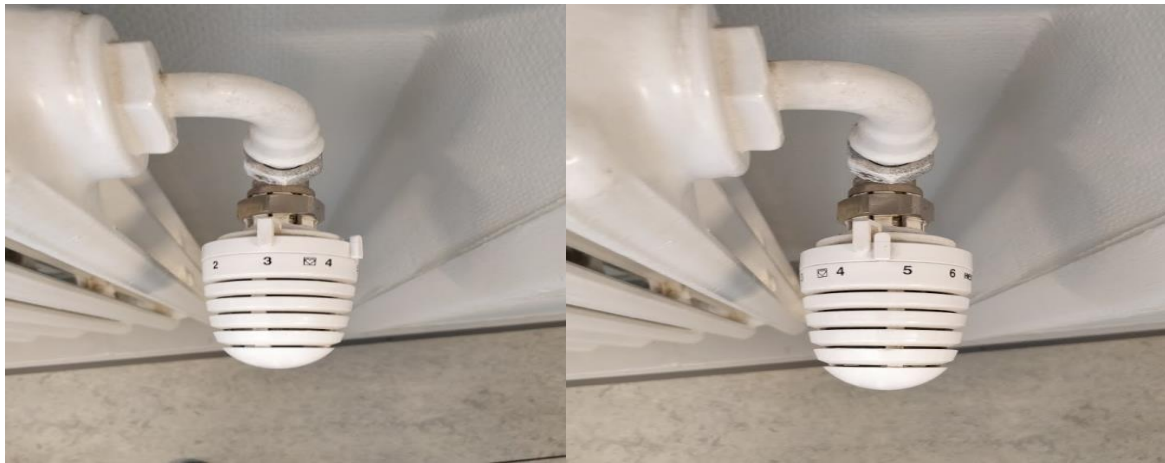
Figure 10 - Radiator thermostat minimum and maximum setting

Both rooms have three of the WT2 installed, each with radiators beneath them. The extracts are placed near to the entrance of each room. The mechanical ventilation is operating 24 hours a day, every day of the year, and does not have a time or season schedule. The radiators have thermostats placed by the valves that can be turned between the 3 and 4 setting, as seen in

Figure 10. It cannot be set to a higher or a lower setting. It is not known if there is a time or season schedule for the heating system.

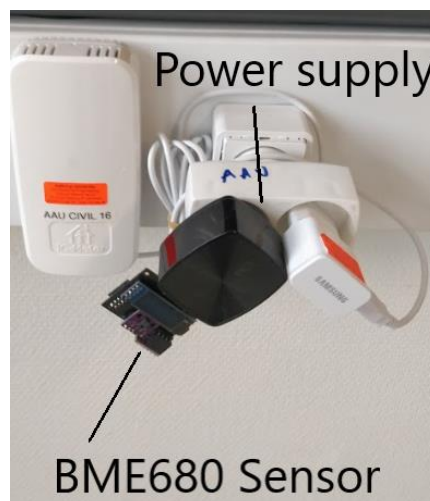
Figure 12 - Setup at the school with the BME680 sensor and power supply

In Figure 12 the setup of the BME680 and power supply at the school can be seen. The sensor is placed right below the teacher's smart board approximately at the center width of the room at 0.9 m.

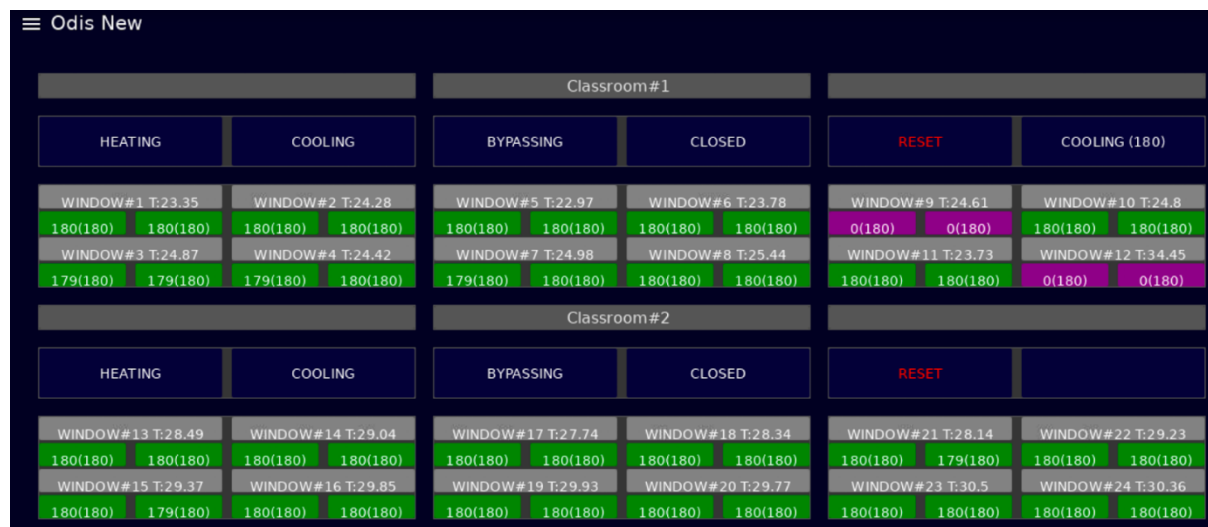
Figure 13 - Overview of the window valves and operation mode

Figure 13 show the overview of each of the window cavities, their temperature and their valve position in degrees. WINDOW #1 and WINDOW #2 are the top cavity of the window furthest to the left in room 1. While WINDOW #3 is the lower left cavity and WINDOW #4 is the lower right cavity of the window. This pattern continues for all the window cavities in the two rooms. The operation mode can also be seen in the dark blue squares stating e.g. closed, bypassing, heating or cooling.

The electrical controlled valves were controlled by a processor called a Raspberry Pi, which sends the commands to the window valves and logs the measurements of the window sensors and the rooms sensors. One processor was placed in each room, so each room acted independently according to the dedicated Raspberry Pi's command.

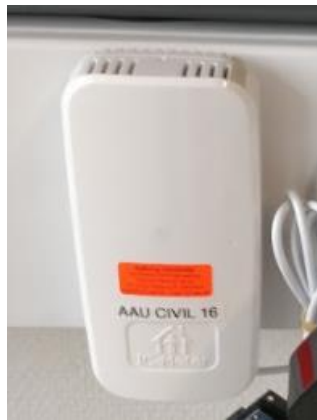
In order to measure the indoor environment Indoor Climate meters or IC meters were used. These are instruments that can measure precisely relative humidity, operative temperature and CO₂ concentration (*Hvad er IC-Meter? | IC-Meter*, 2019). It can measure these values, send them to an online server where it visualizes the data and stores it for later download for treatment. This is an all-around sturdy and reliable measuring device that is used by Aalborg University. An IC meter can be seen on Figure 14.

Figure 14 - IC meter instrument

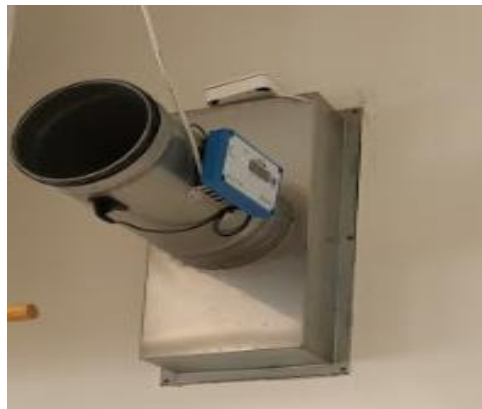
Figure 16 - Lindab flowmeter

To measure the airflow from the extraction, Lindab FTMU pressure differential sensors were used. This instrument uses ultrasound sensor to measure the airflow. The instrument can be seen installed on the mechanical extraction duct in Room 2 of the Ødis school in Figure 16.

All sensors have been calibrated at the Aalborg university lab, and calibration curves were applied to the data when treated (See Appendix 8.2).

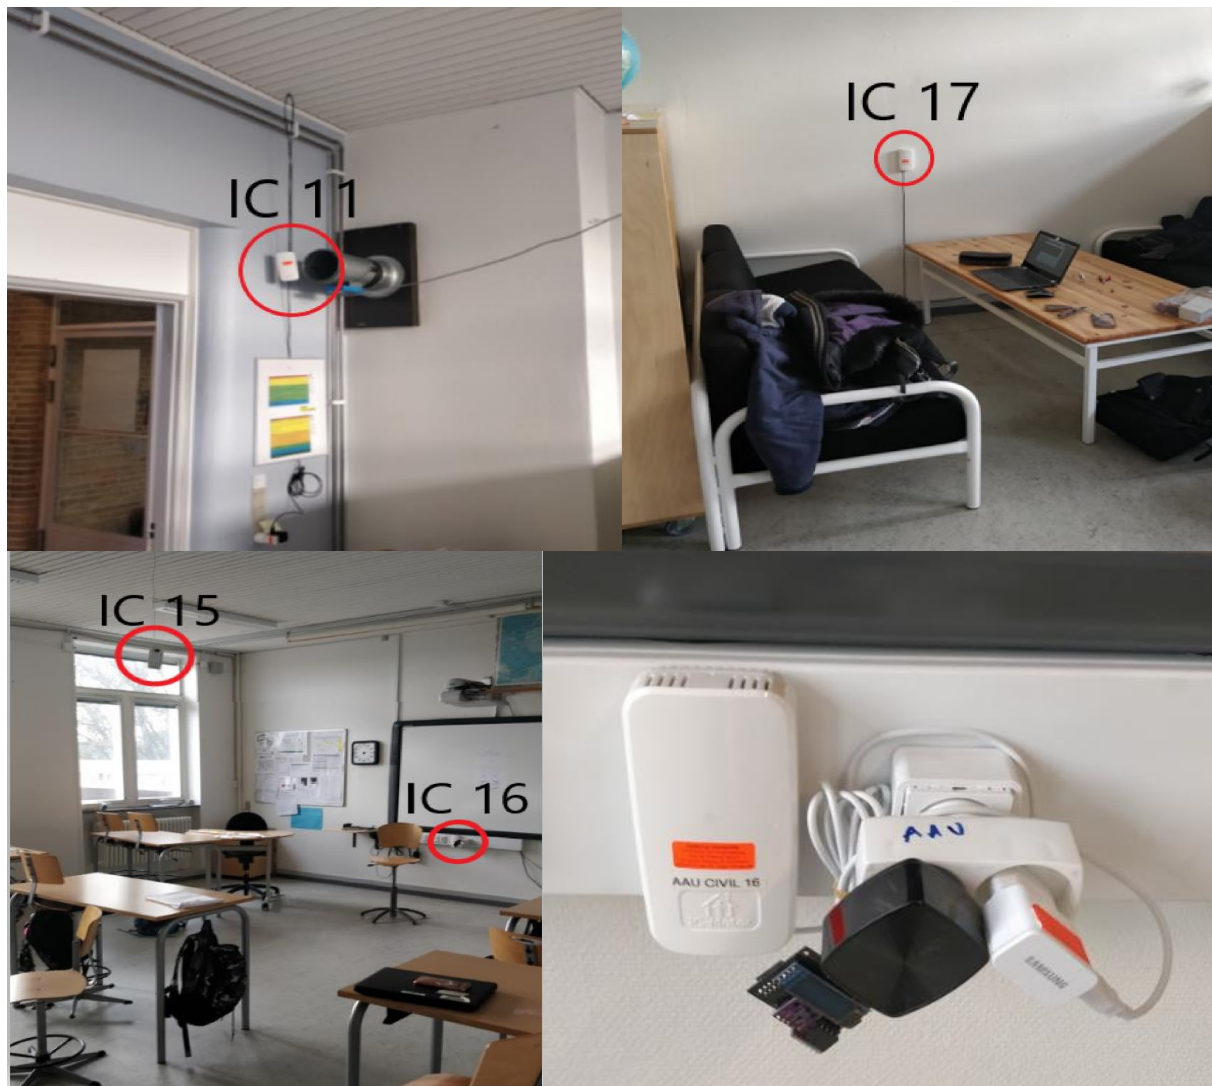
Figure 17 - IC meter numbers and placement in Room 1 with natural ventilation

The IC meters in room 1 were placed as seen in Figure 17 where the IC 11 (at the exhaust) & 15 (in the center of the room above the occupied zone) were placed at the same positions as in the previous investigation. This was done to reduce the differences in the measurements caused by different placements of the IC meters. Two IC meters (16 & 17) were added to each room to investigate if the room had a uniform indoor environment or if it had temperature and CO₂ stratification. Furthermore, one of the additional IC meters (IC 16) was placed right next to the sensor that controls the windows to investigate if the placement was adequate for controlling the ventilated windows.

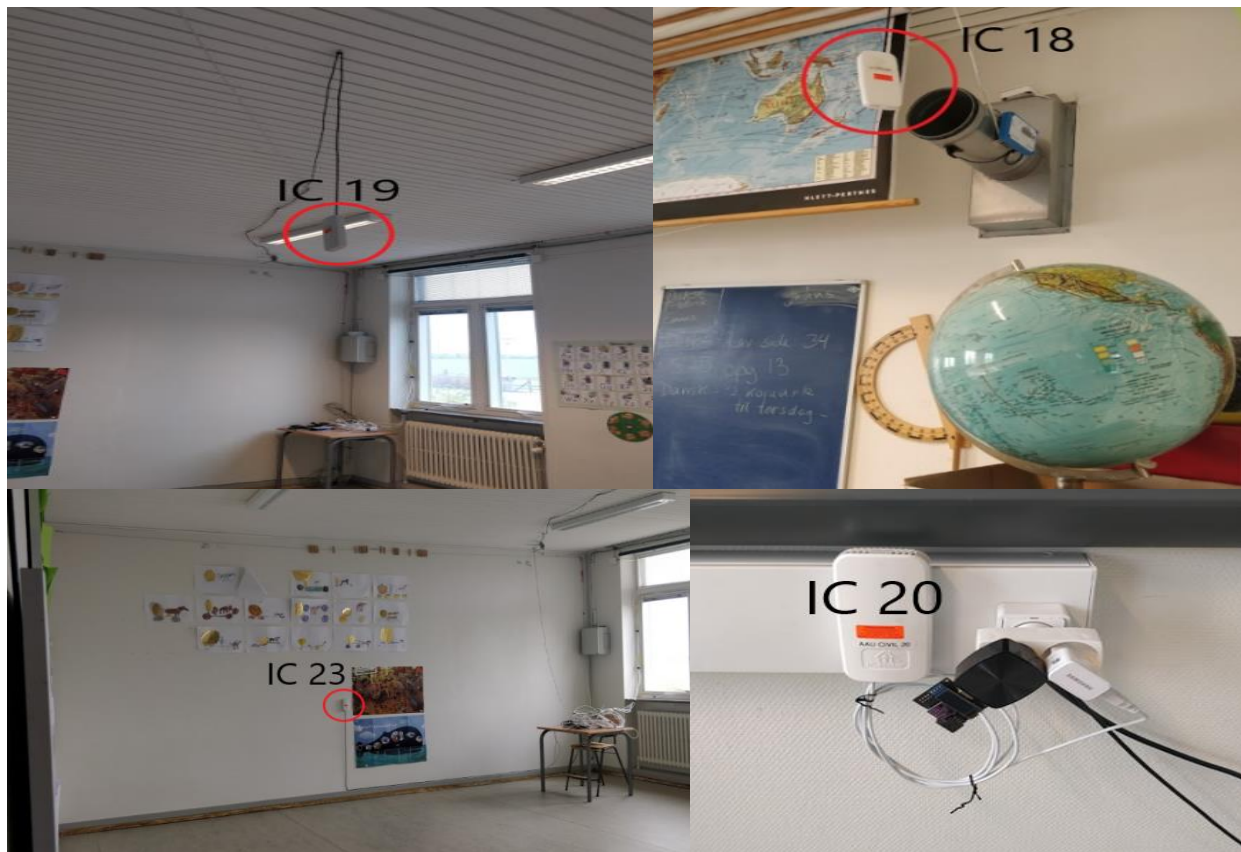
Figure 18 - IC meter number and placement in Room 2 with mechanical extraction

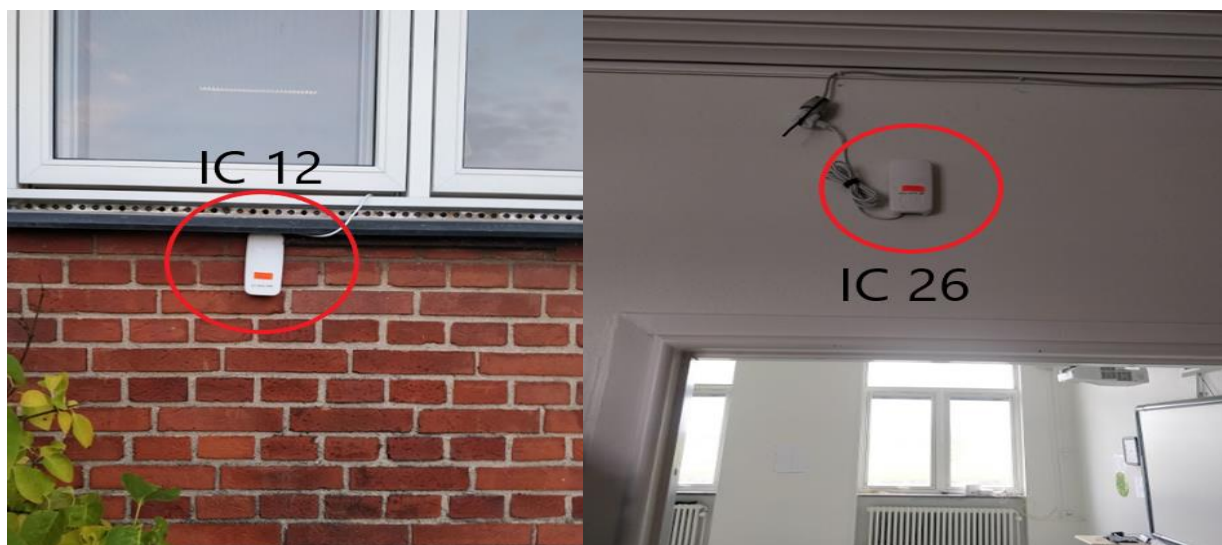
Figure 19 - IC number 12 & 26 and their placement, outside (left) & hallway (right)

Figure 19 shows two additional IC meters placed outside at room 1 (IC 12) and in the hallway (IC 26) at the entrance of room 2. IC 12 was placed outside in order to see the influence on the window performance and indoor environment. IC 26 was used in order to assess if the door was open, causing the indoor environment in the rooms to not ventilate using clean air from outside but the polluted air from the hallway. More details about the placement of the IC meters is shown in Table 5.

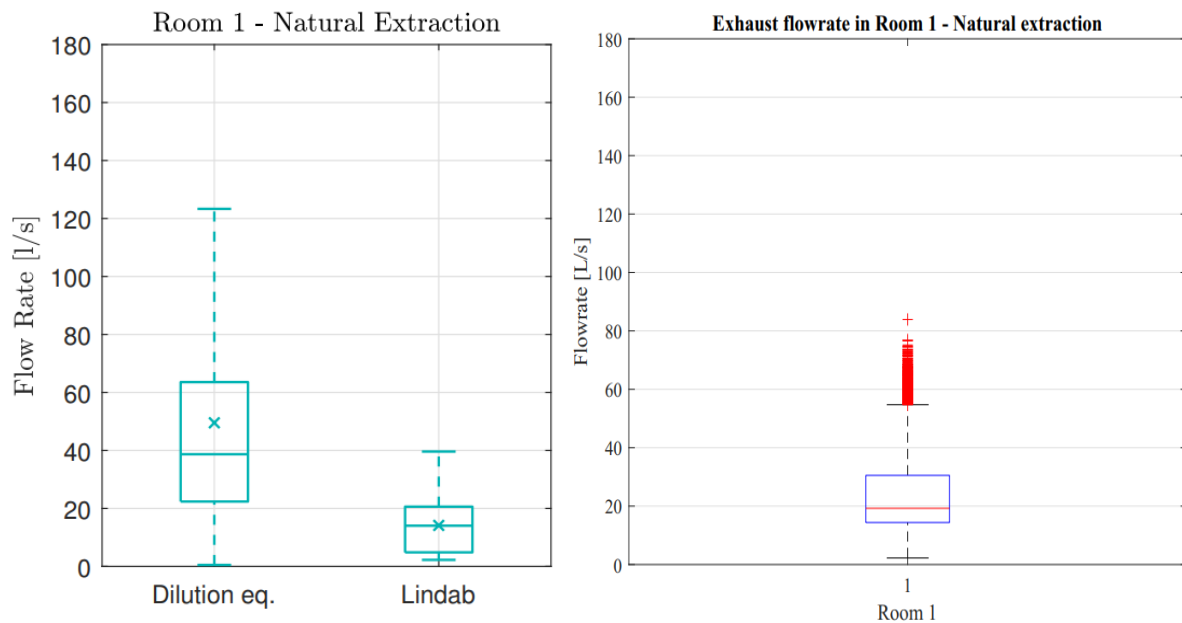
Figure 29 - Comparison of exhaust rates from the two investigations and the dilution equation in room 1 (Lindab is from the previous investigation WT1, Room 1 is from the current investigation WT2 from Lindab sensor. (Left figure is from previous investigation; right is from the current investigation)).

This could help explaining why there was a 12% lower percentage of time with CO₂ levels above 1000 ppm. This is assuming that a higher exhaust means a higher ventilation airflow from the WT2. The measured values from the current investigation was still less than the dilution equation. The increase in airflow could indicate that WT2 had a lower pressure resistance than WT1.

that the dilution calculations were still valid for this investigation. This was therefore also used for comparison in Figure 29 and Figure 30, to see how close the measured results were to the theoretical minimum flow need.

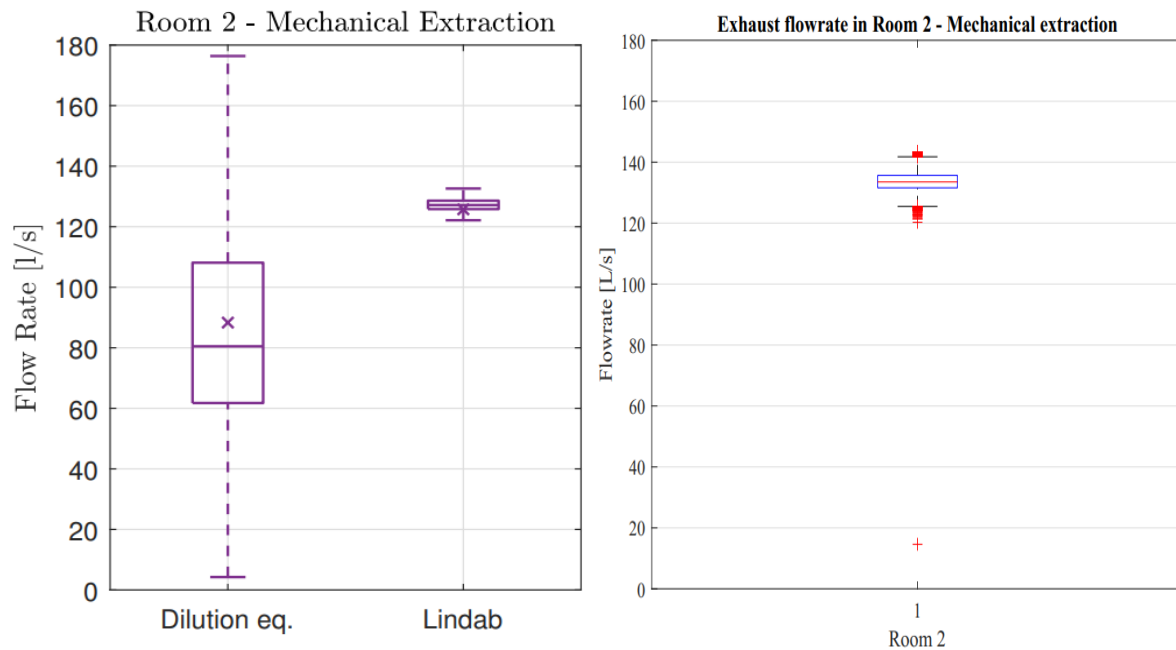
Figure 30 - Comparison of exhaust rates from the two investigations and the dilution equation in room 2 (Lindab is from the previous investigation WT1, Room 2 is from the current investigation WT2 Lindab sensor. (Left figure is from previous investigation; right is from the current investigation).

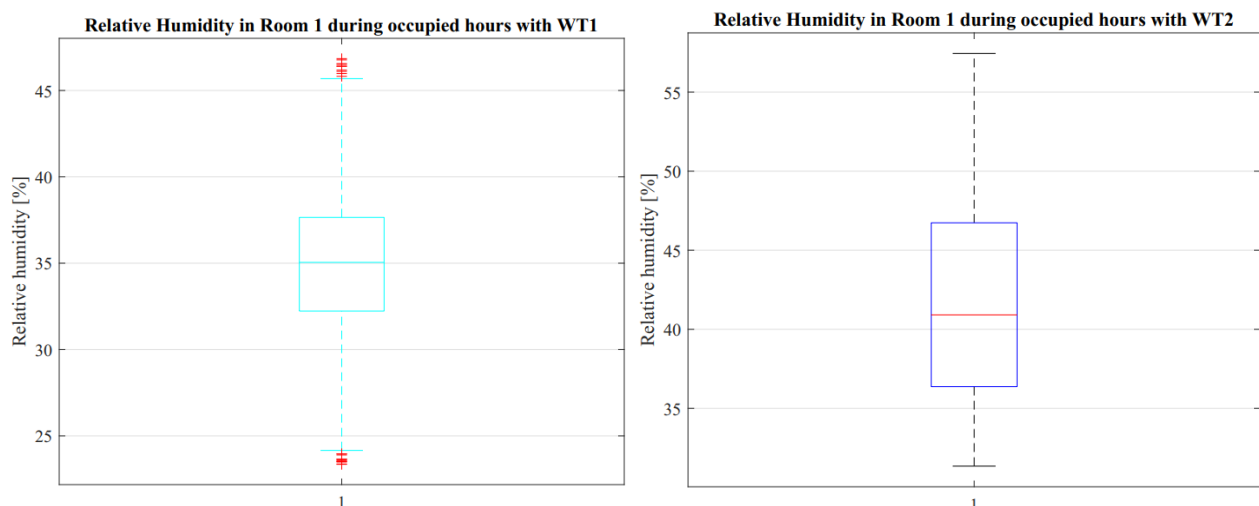
Figure 31 - Relative humidity in room 1 – Natural ventilation with WT1 (Left) and WT2 (Right) 10 min averaged of occupied hours, notice the difference in scale

The WT1 measurements results in a lower category than WT2 caused by the relative humidity level being below 25%.

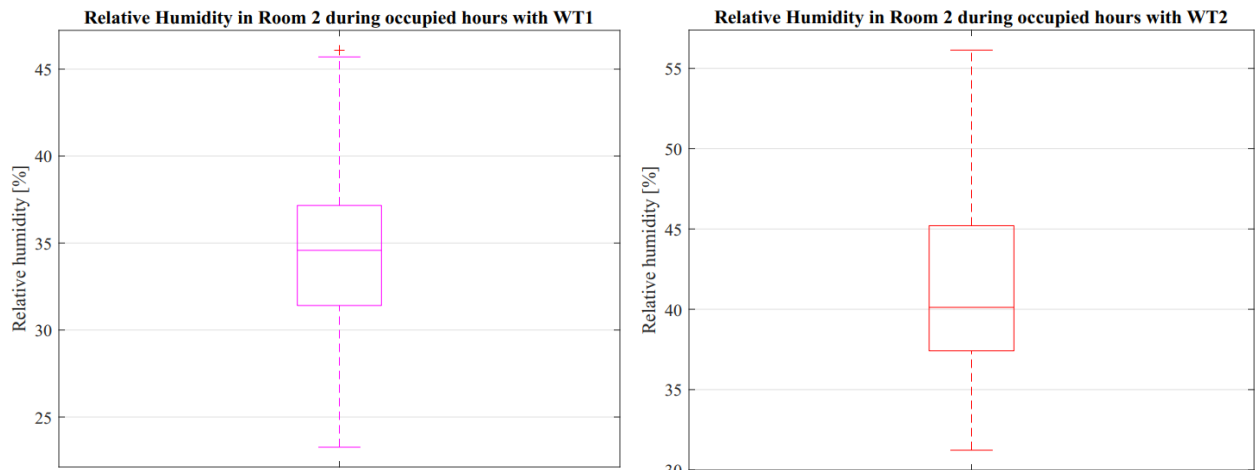
Figure 32 - Relative humidity in room 2 – Mechanical ventilation with WT1 (Left) and WT2 (Right) 10min average of occupied hours, notice the difference in scale

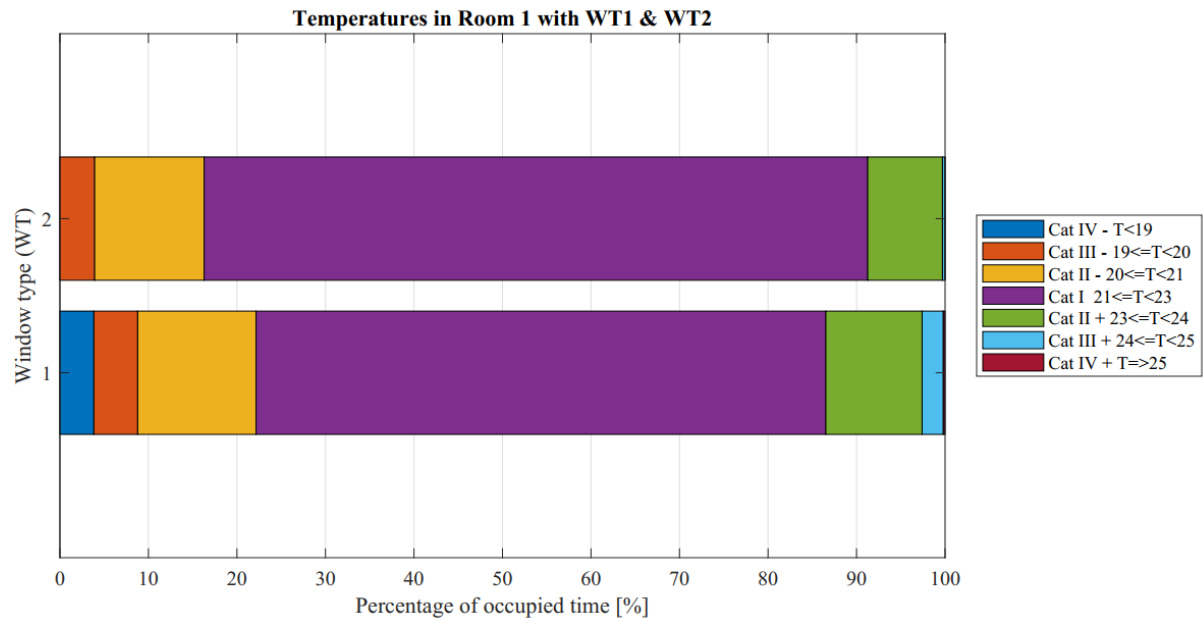
Figure 33 - Percentage of Temperature within categories in Room 1 for WT1 (Bottom) and WT2 (Top) 10 min average of occupied hours

Comparing the distributed temperatures in room 1 has changed within category -II and -IV with a reduction of 6%, within Category I it is 11% and within category +II to +IV a reduction with 5%. It can be observed on Figure 33 that none of the measurements reaches above 25°C which means neither are in category IV.

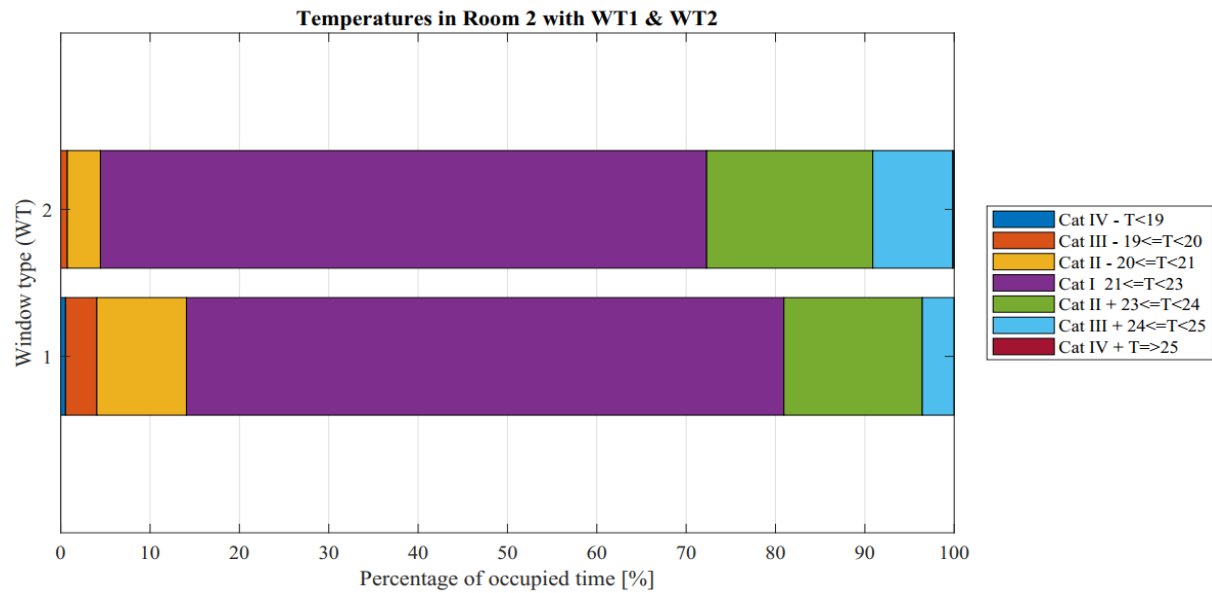
Figure 34 - Percentage of temperature within categories in Room 2 for WT1 (Bottom) and WT2 (Top) 10 min average of occupied hours

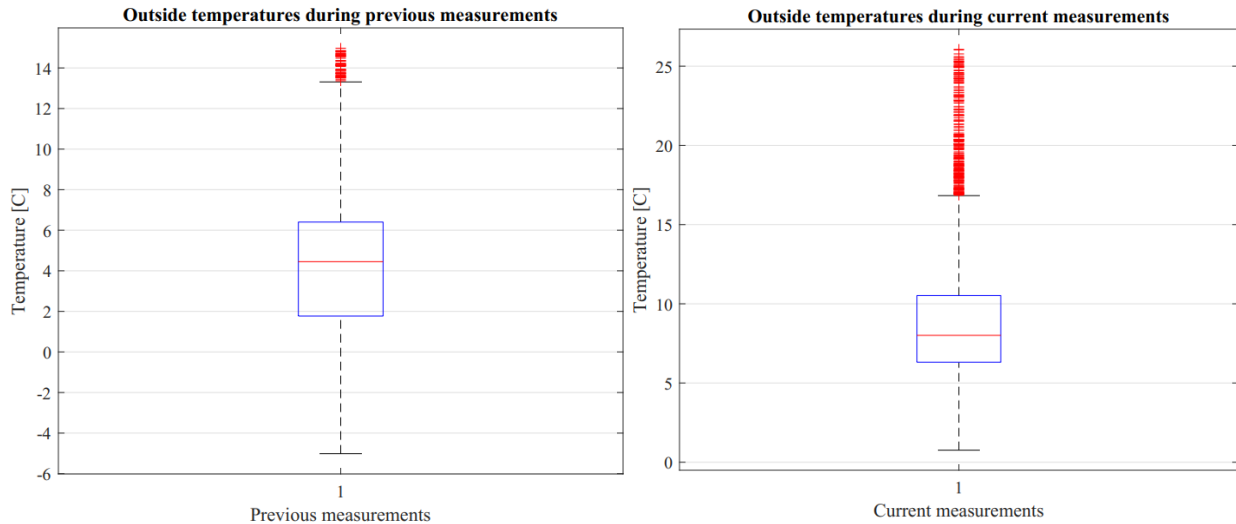
In order to assess how much the outside temperature had been different during the two measurements, which could affect the indoor temperatures, a comparison of the two outside temperature measurements was performed.

Figure 35 - Boxplot of outside temperatures during measurements with WT1 (Left) and current measurements WT2 (Right) notice the difference in scale.

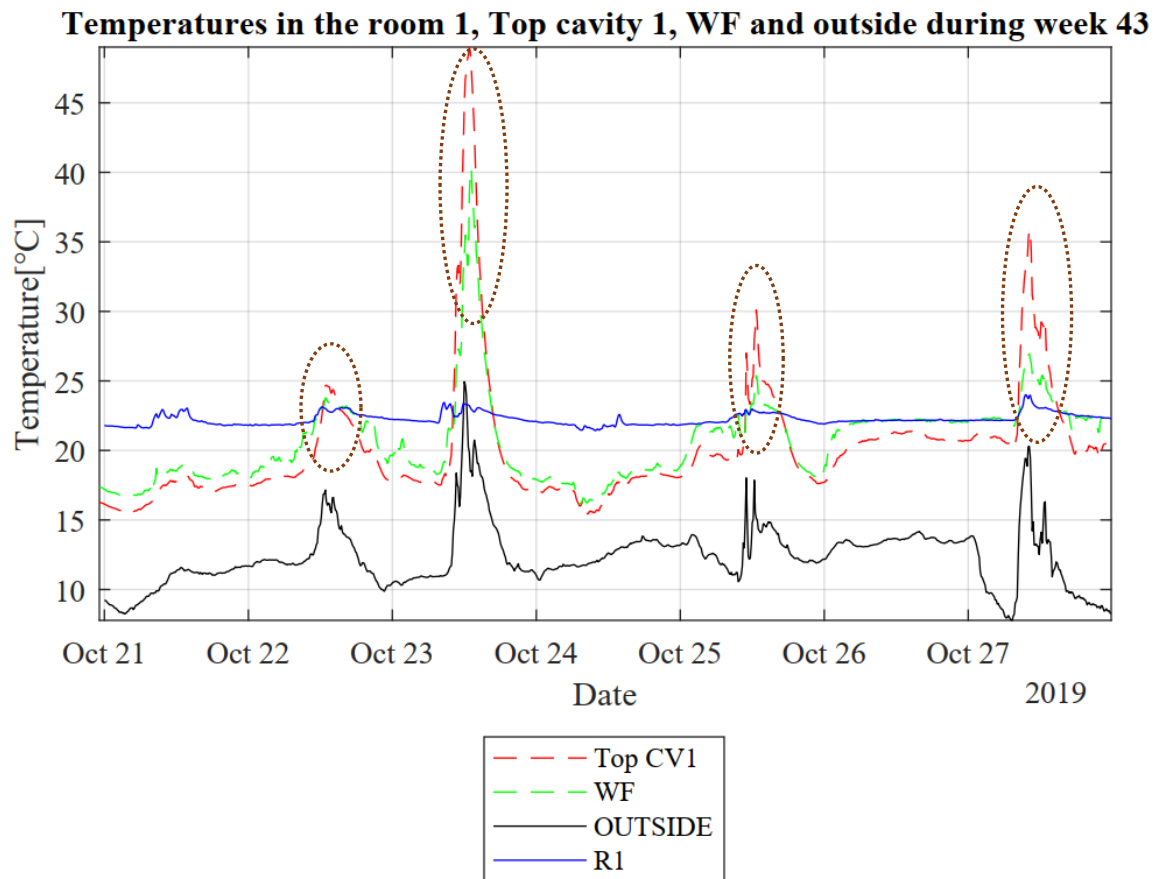
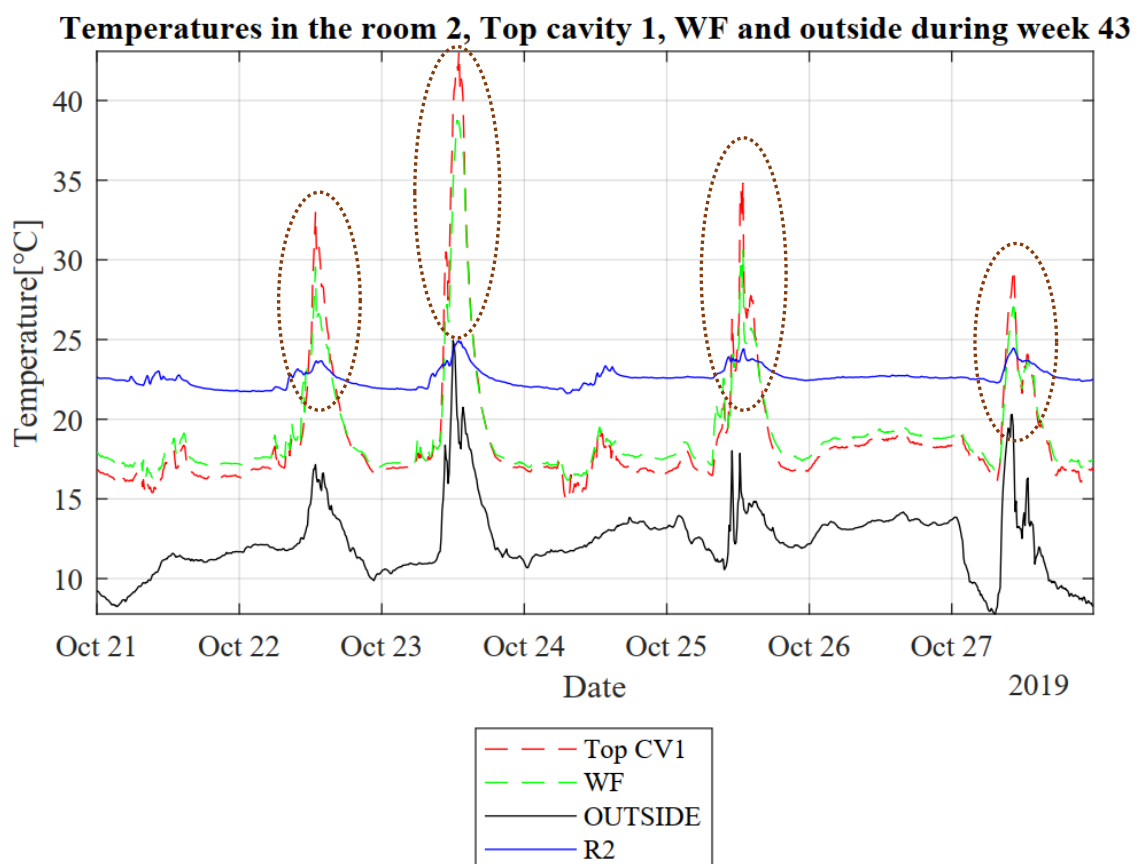
Figure 37 - Temperatures registered in the rooms 1, 2, Top cavity 1(P4), WF(P8) and outside during the week 43

After this step, the investigation focused on the air temperatures measured at the top cavity 1 for the WT2 in the 2 studied rooms during weeks 43 and 47, as presented in Figure 37 and Figure 38.

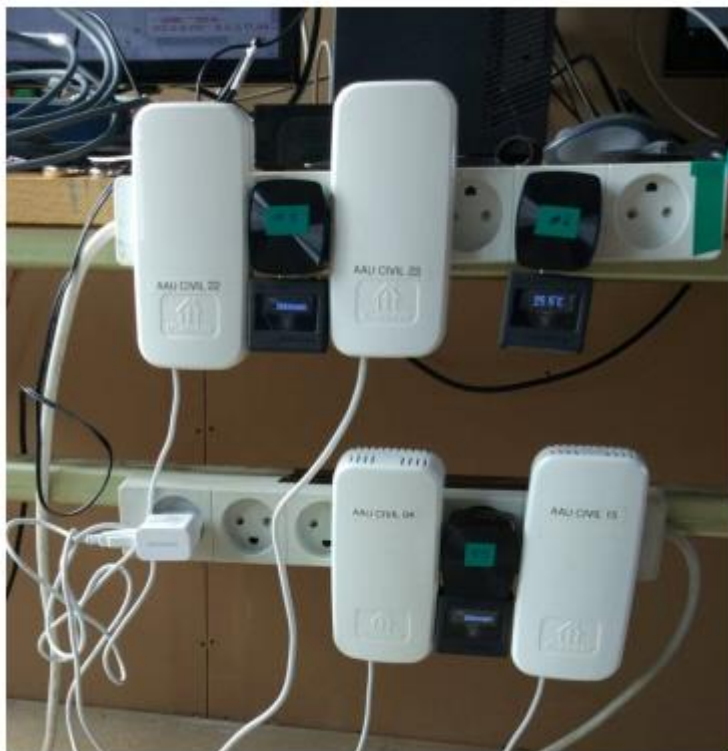
Figure 59 - Setup used for the sensors test.(Bonet Arbos et al., 2019)

All the parameters were tested in the laboratory room, except for the CO₂ analysis that was performed in a smaller room, varying the occupancy during the time of the investigation. Three Bosch BME680 sensors (named S1, S2 and S4) and four IC meters acting as reference sensor were used, as presented in Figure 59.

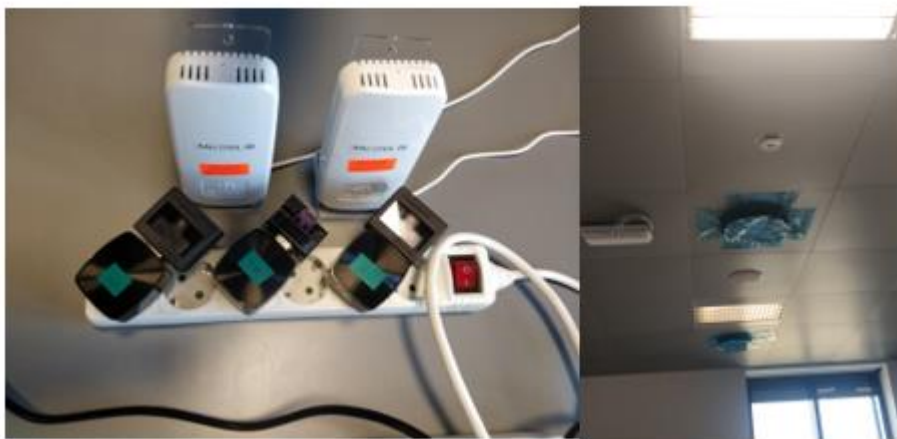
Figure 61 - Experiment setup (IC meters – white devices and Bosch BME680 sensors – black devices)

The experiment took place in a working room (room 1.312) on Thomas Manns vej 23 at Aalborg University, during the following days: 24th, 25th, 28th, 29th and 30th of October 2019. The following equipment was used: three Bosch BME680 sensors (named S1, S2 and S4) and two IC meters located in the middle of the room as well as two meters from the window, as illustrated in Figure 61.

The sensors named S1 and S4 were integrated in a case named climawintech and the sensor S2 was not encased. The ventilation diffusers were sealed to guarantee that the air supplied and extracted to the room wouldn't disturb the IC meter readings of CO₂. During the time of the experiment all the users of the meeting room registered their entry and exit of the room, and every time a door or window was opened was also registered. The occupation time schedule was between 07:00 AM until 17:30 PM. Knowing the occupation schedule of the room, as well as the number of times that the door and/or window was open, it was possible to investigate and achieve certain conclusions about the sensor behavior for the temperature, relative humidity and the study of the correlation between the VOC readings and the occupation.
