STUDENT REPORT

AALBORG UNIVERSITY
DEPARTMENT OF MATERIALS AND PRODUCTION

Pitting Resistance Study after the Laser Forming of AISI 304 Stainless Steel and its Remediation Methods of Chemical Pickling and Laser Ablation Processes

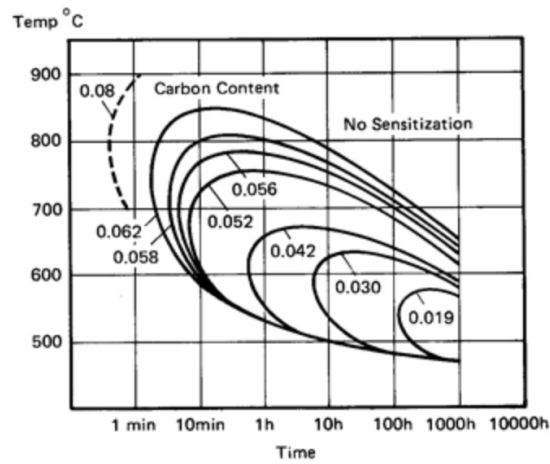
Figure 5: Time – Temperature – Sensitization Curve for 304 SS Grade[14][52]

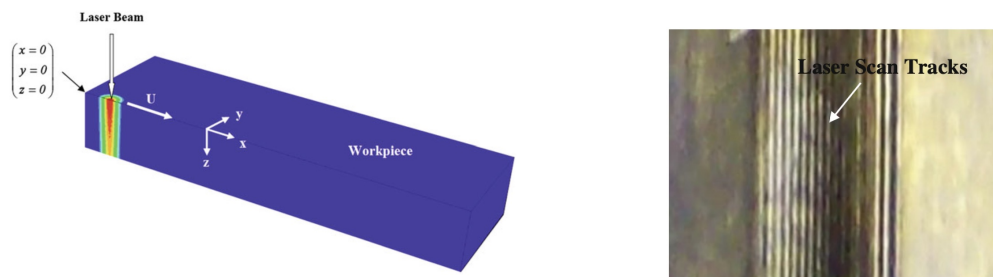
Figure 6: Diagram of laser heating process, in Figure 7: Laser generated scanning marking/tinting indicating localized heating, and its coordinate system [17].

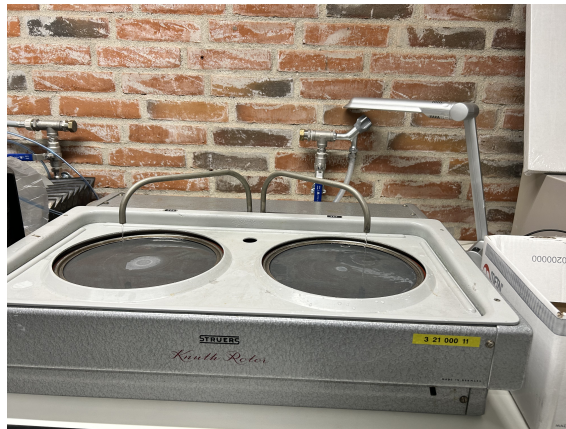
Figure 23: Rotary Grinding Machine

All coupons reserved for the chloride immersion test were ground and polished by a rotary grinding machine (figure 23) with no.280 sandpaper only at their four edges to avoid any crack or pitting propagation from the exposed sides. The acidic immersion sol. was ferric chloride ($FeCl_3$) with 0,75[wt%] concentration. The duration of the test was 24 [hr] at 20[°C] for three identical samples per study case. Each coupon was submerged under the immersion sol. individually located inside a larger water bath that maintained the desired temperature, as depicted in figure 24. A mixer was helping to maintain the temperature, and a cooler/heating source was stabilizing the water bath temperature. Lastly, visual examination and mass loss statistical analysis took place. Under a 20x magnification of a microscope, the observations for potential deterioration were checked.

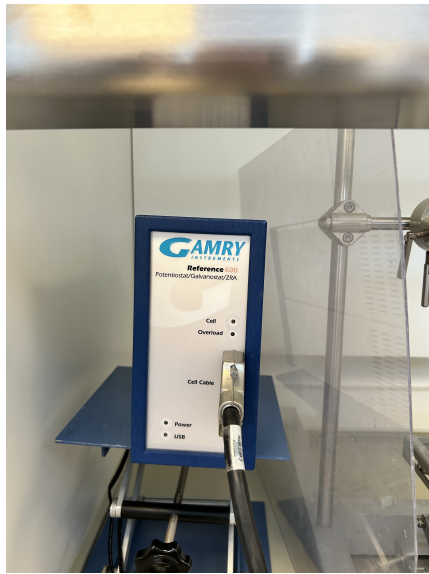
Figure 25: Gamry Potentiostat

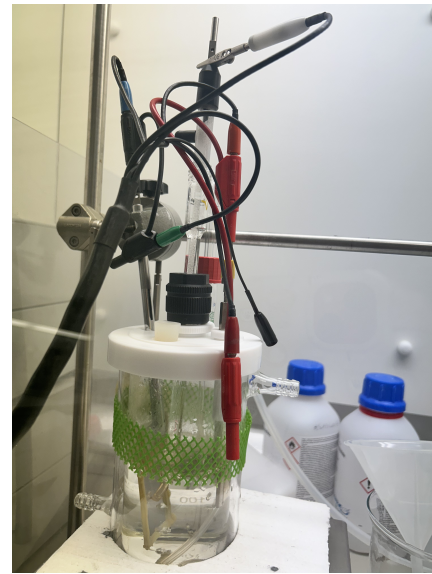
Figure 26: Jacketed Corrosion Cell Used for Testing 304 SS Coupons

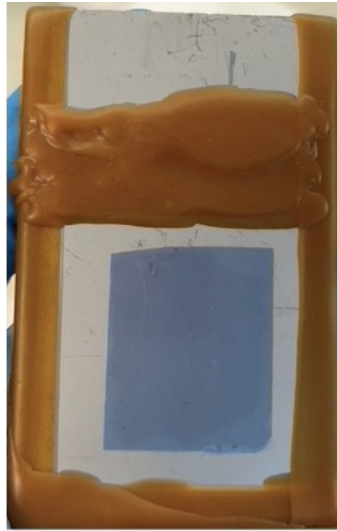
Figure 27: Example of a 304 SS Coupon that was passivated with the taped area sealed from the nitric acid passivation sol., and later waxed.

1. Applied a waterproof tape cover in the location indicated in figure 27. The tape was located on top of the HAZ when heat-tinted. The dimensions of every tape used on coupons were $25 \times 30[cm]$. The purpose was for the covered area not to get passivated by the nitric acid, thus later being more susceptible to pitting corrosion when tested in the NaCl medium.
2. 20[wt%] nitric acid passivation for 30[min] at $60[^\circ C]$ with the tape cover.

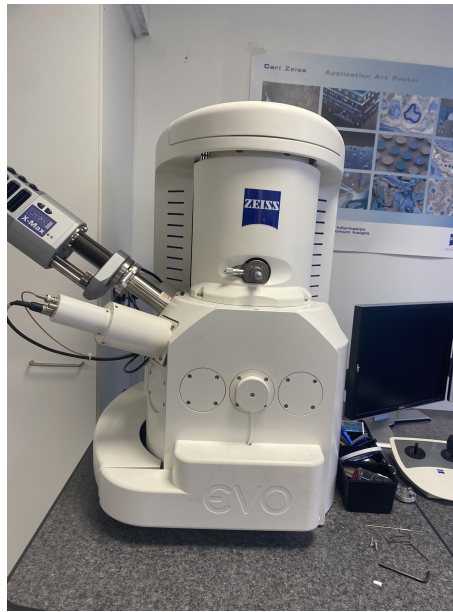
Figure 28: SEM/EDX System at Aalborg University

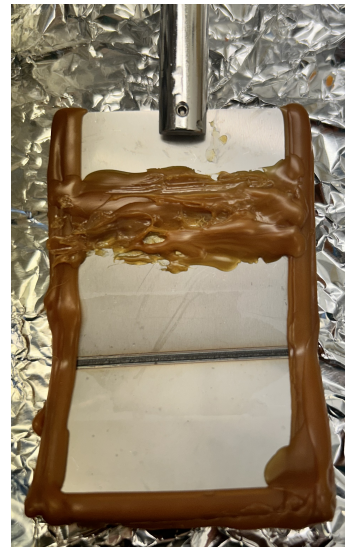
Figure 33: Three-electrode setup with bent and purpose of experimental process development testing
 Figure 34: 304SS welded coupon setup for CPP with the purpose of experimental process development testing

Lastly, a welded coupon was tested to validate our selected method of passivation for the coupon preparation. The tape was sealing partially HAZ. The picture of the coupon in figure 36 shows a welded coupon with a thin HAZ that was welded several times on the same area and had an intense black surface colour, thus being heavily heat-tinted/stained(see figure 33 and 34). However, the visual results indicated no pitting on the surface. Anyway, it would have been hard to see pitting due to the dark staining. Nevertheless, from the welded coupon CPP curve, there was no pitting, only uniform corrosion at a lower potential(thus lower corrosion resistance) than the other non-heat-treated coupons in this method development study. Also, the welded coupon

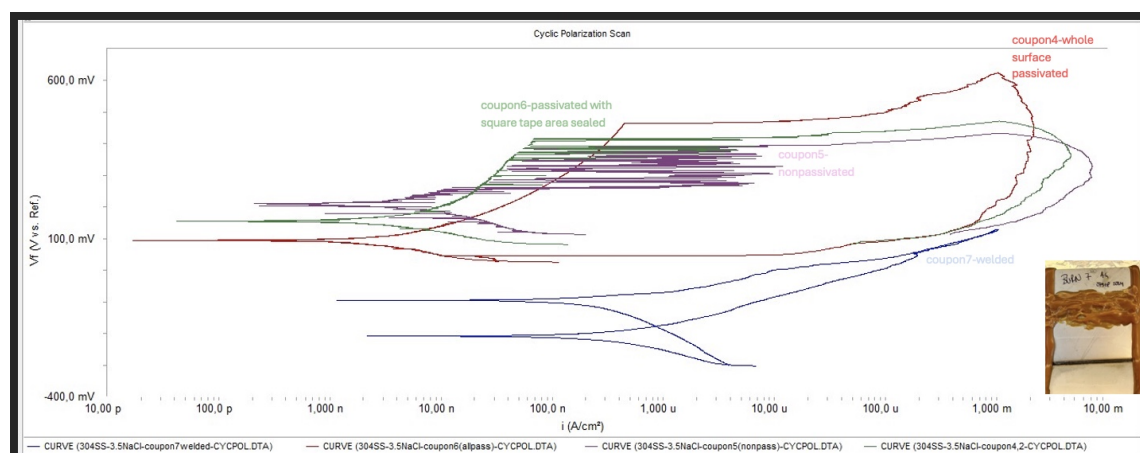
Figure 36: Potential vs Log of Current Density Gamry Plot for Process Development for Experimental Procedure Coupons.
